Observations on the Mechanisms of High Resistance Junction Formation in Aluminum Wire Connections

Dale Newbury* and S. Greenwald†

National Bureau of Standards, Washington, D.C. 20234

June 19, 1980

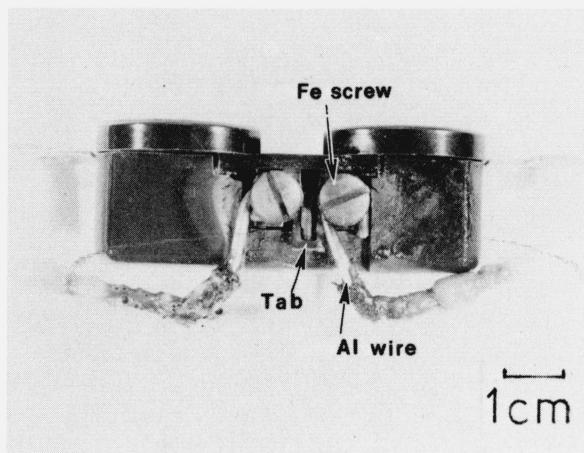
usually shorter [3]. Temperatures as high as 400 °C have been measured in this study at the break-off tab (fig. 2). In the center of the glow area itself, the visible color may vary from a dull red to a bright white, indicating maximum temperatures in excess of 1200–1300 °C [1].

FIGURE 2. *Duplex junction box showing wire and screw components and location of tab for temperature measurements.*

Some of the connections tested developed a glow failure which could be sustained for considerable time. Sample "A" was one such example (see table 1) which developed a glow after only 8 h of cycling. This specimen was left in the circuit and continued to glow, but was finally removed after 4 more hours had elapsed. The total number of "on"-“off" cycles at that time was 36. In other tests, e.g., specimens C and D in table 1, the test was interrupted at earlier stages in the development of the glow phenomenon in an attempt to trace the sequence of the events. Temperatures were measured during the test with a thermocouple connected to an electronic digital thermometer at the position shown in figure 2.

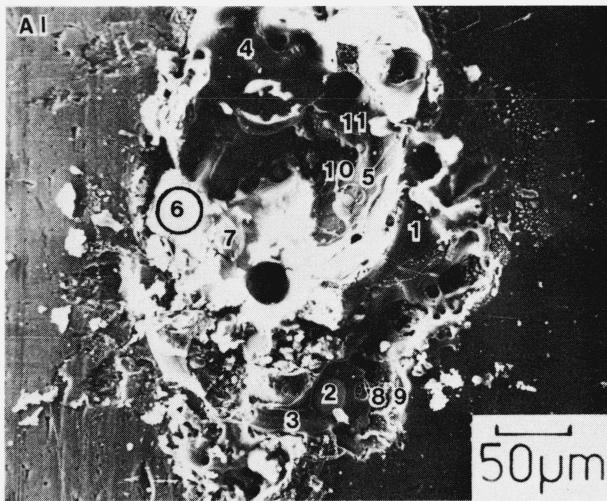
FIGURE 3(a). Damage crater observed on aluminum wire after loose junction glow simulation.

Analyses at points indicated are listed in table 2 (SEM image).

smooth appearance which appears to be a result of melting and solidification. X-ray microanalyses of the areas indicated in figures 3(a) and 4(a) are listed in table 2. The analyses reveal that both aluminum and iron are present in significant amounts within both crater regions. Since the surrounding matrix material is either nearly pure aluminum or nearly pure iron, the intimate mixing of these elements in the crater regions indicates that significant material transport occurred between the wire and the screw during the glow phenomenon.

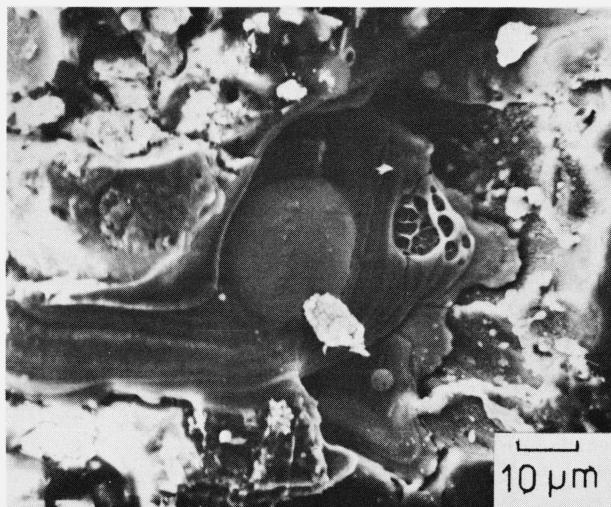
FIGURE 3(b). Structure located at position 2 in figure 3(a) (SEM image).

Close examination of the craters revealed a number of interesting features. Ball-like structures, marked in figures 3(b) and 4(b), found in both craters contain mostly iron,

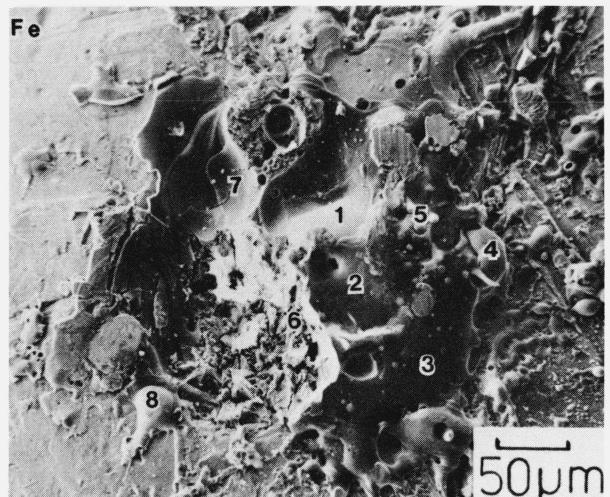
FIGURE 4(a). Damage crater observed on iron screw after loose junction glow simulation.

Analyses at points indicated are listed in table 2 (SEM image).

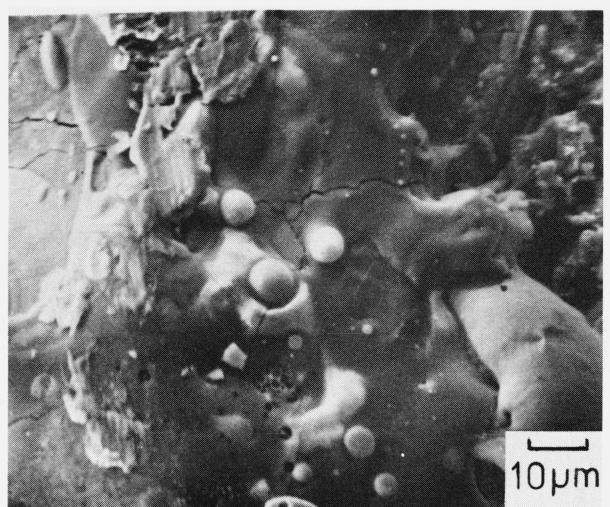
FIGURE 4(b). Ball-like structures observed in region of figure 4(a) (SEM image).

with only 2–4 percent aluminum [table 2, Al(2,7); Fe(4,5,8,9)]. Elongated structures, indicated in figure 4(c), are also composed mainly of iron. The spherical and elongated structures appear to be the result of melting and rapid freezing of the metal. The presence of molten iron during the glow phenomena indicates that temperatures in excess of 1500 °C are generated in the region of the crater.

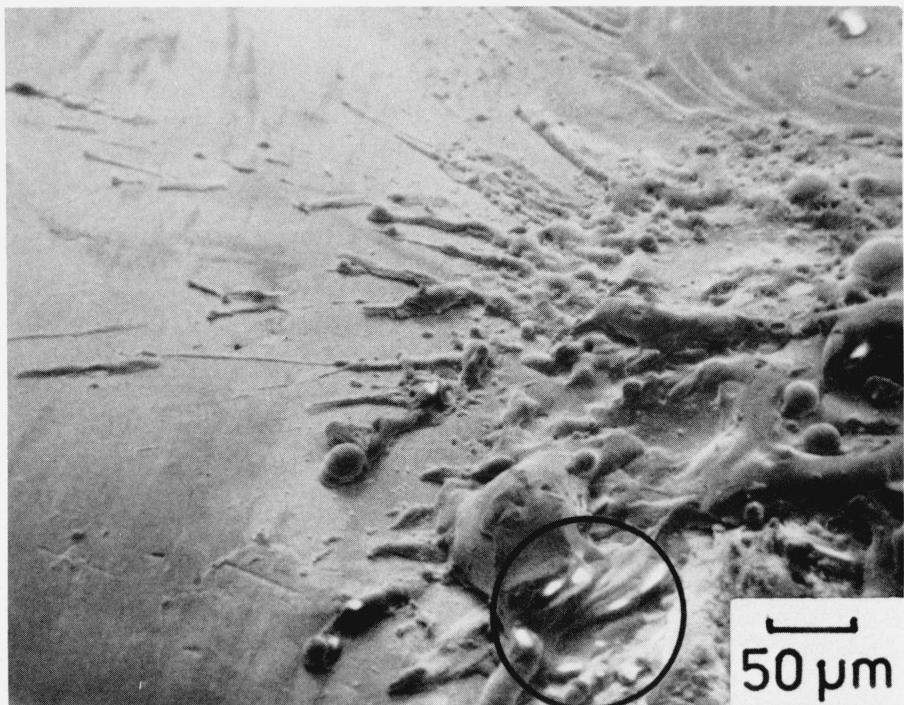
FIGURE 4(c). *Splatter-like structures on edge of damage crater on iron screw.*

The circled area shows evidence of charging (bright areas) (SEM image).

charging. These areas are occasionally observed within the craters, e.g., as indicated by circles in figures 3(a) and 4(c). The regions of charging in the image represent only a small portion of the crater area, and thus the dominant character of the crater is conductive.

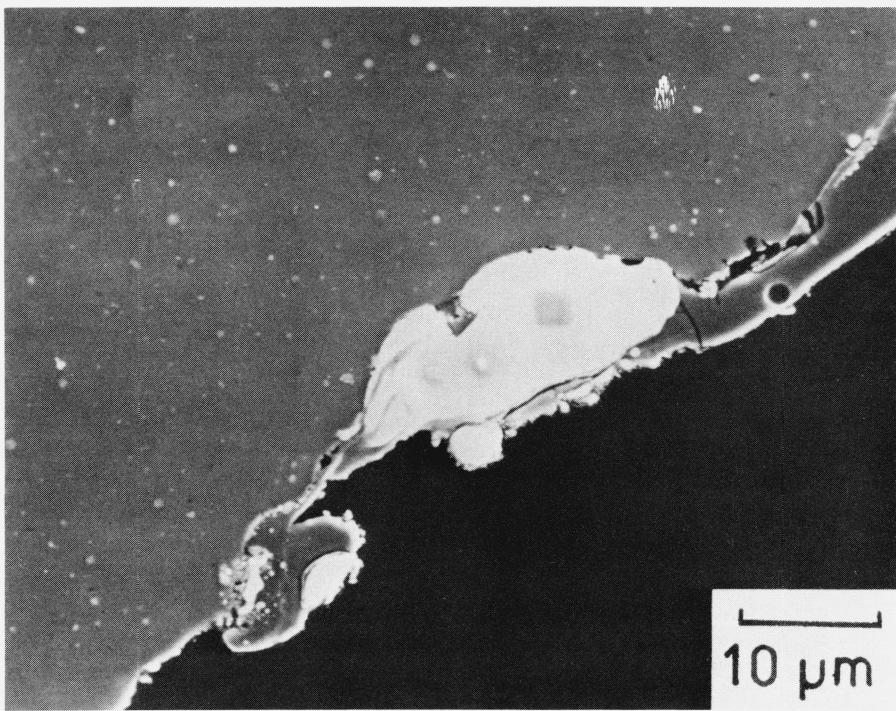
FIGURE 5. Metallographic cross section through a damage crater on aluminum wire (SEM image).

The sub-surface structure of a crater formed during the glow process on the aluminum wire was examined in a metallographic cross section (fig. 5). The electron image of this structure reveals a new phase at the surface of the wire below the crater, which is found to contain principally aluminum and iron with a small amount of copper (table 2).

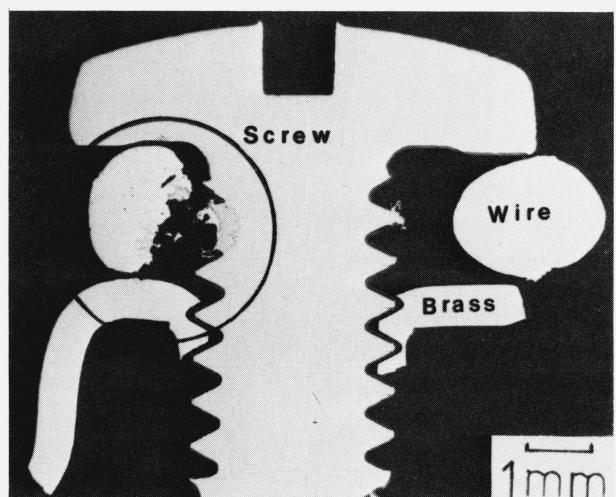
Sample A (table 1) underwent a sustained glow, 4 h in duration reaching a measured temperature of 350 °C. The metallographic cross section (unetched, figs. 6(a) and 6(b)) showed evidence of extensive reaction at the aluminum wire/iron screw interface and at the aluminum wire/brass plate interface.

FIGURE 6(a). Optical micrograph of aluminum wire/iron screw/brass plate from duplex receptacle following glow failure (sample A, table 1).

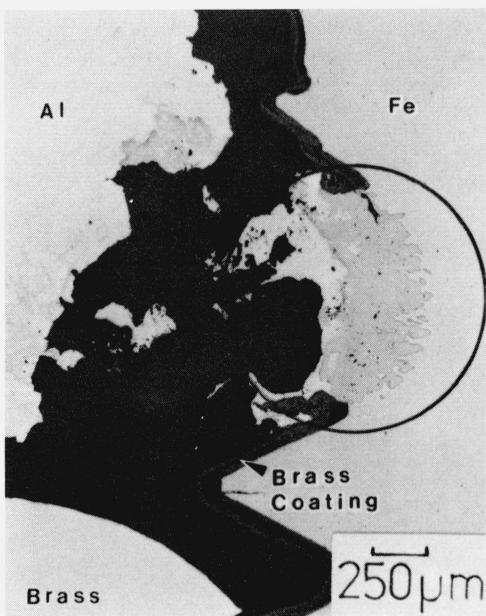
FIGURE 6(b). Optical micrograph of aluminum-iron region of figure 6(a) showing reaction zone (unetched).

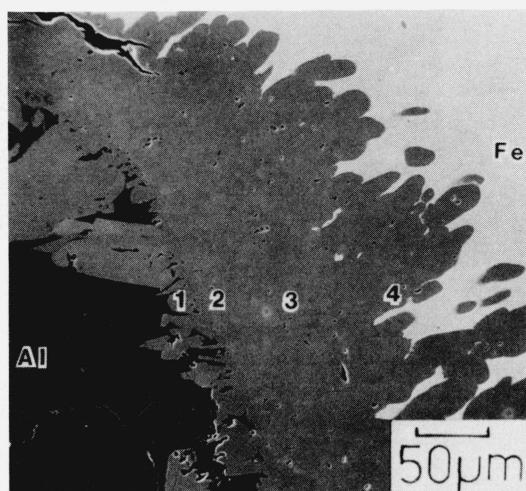
(fig. 7) reveals a complex reaction zone which consists of two distinct layers located between the aluminum and iron. Quantitative analyses (table 3A) performed at the locations indicated in figure 7 reveal that the thin outer layer (near the aluminum wire) consists of 62 wt% Al—38 wt% Fe—0.5 wt% Cu while the thick inner layer (near the iron screw) consists of 57 wt% Al—43 wt% Fe—0.1 wt% Cu. Zinc (from the brass electroplated coating) was not detected.

FIGURE 7. SEM micrograph of the circled region of figure 6(b). The analyses at the indicated locations are listed in table 3A.

The interfaces of this reaction zone with the aluminum and with the iron are both highly irregular, which suggests that the zone is growing into both materials. In this sample, no evidence of a thick oxide layer was obtained.

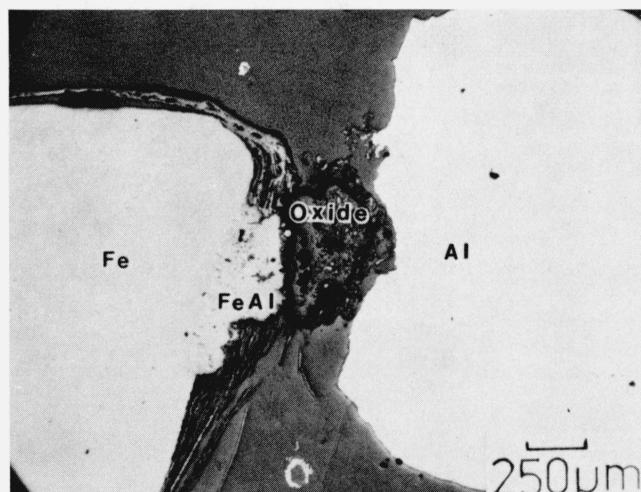
The structures observed in sample A were typical for sustained glow failures. Oxide layers were not usually found. In one sample, however (sample B, table 1), a thick oxide layer was observed in addition to the usual aluminum-iron intermetallic layers. The optical micrograph (fig. 8) of the cross section of sample B shows the reaction zone ("Fe-Al") and the oxide layer. Selected points in these structures were analyzed, as shown in table 3B. The intermetallic layer (figs. 9(a) and 9(b)) contained two distinct regions, with the region adjacent to the wire slightly richer in aluminum. The oxide structure (fig. 9(c)) contained mainly aluminum (table 3B). Note that the measured aluminum weight fraction in this region; 71 percent, is substantially higher than aluminum in stoichiometric Al_2O_3 (weight percent Al is 53%), which

FIGURE 8. Optical micrograph of iron/aluminum interface region in sample B, table 1, showing iron-aluminum interaction region and an oxidized region near the aluminum wire.

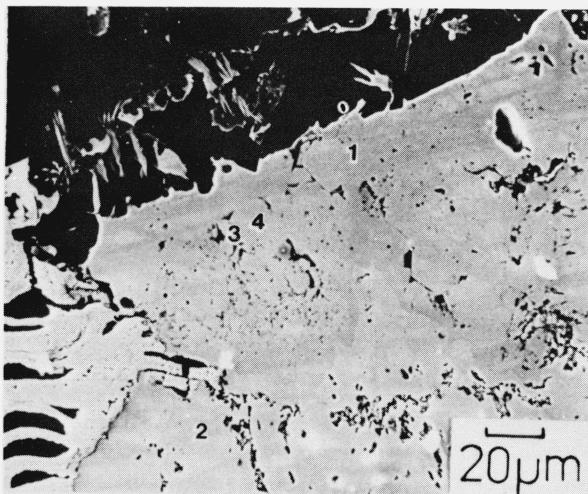
FIGURE 9(a). SEM image of iron/aluminum reaction region in figure 8.

indicates that the aluminum is incompletely oxidized. Inclusions are observed in this oxide layer which correspond to nonoxidized intermetallic compounds (table 3B).

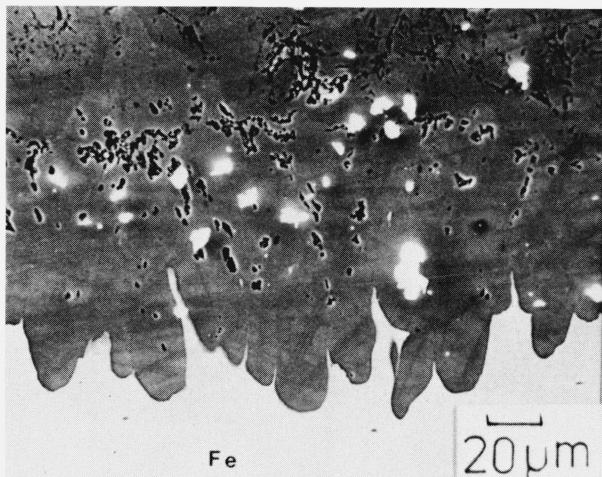
FIGURE 9(b). SEM image of interface between iron/aluminum reaction zone and iron screw in figure 8.

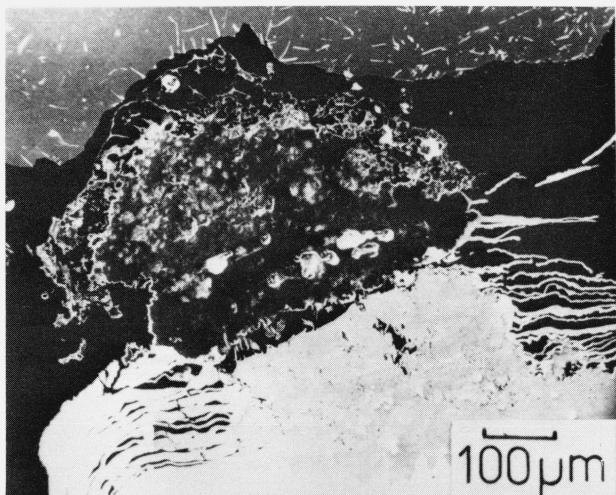
FIGURE 9(c). SEM image of oxide/iron-aluminum reaction zone in figure 8.

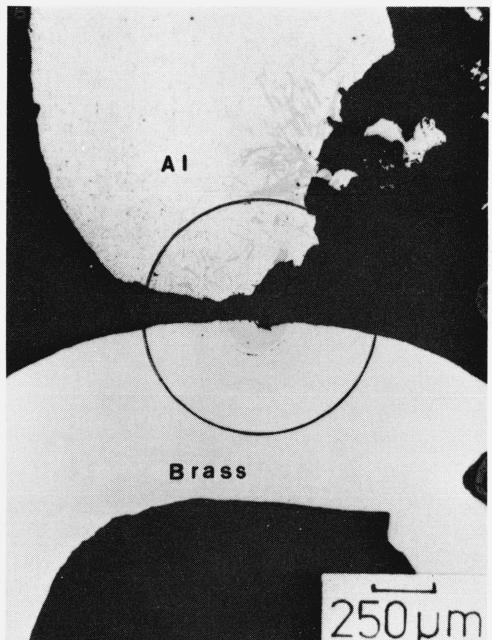
(b) *Brass-aluminum interface.* Reactions are often observed as well at the interface between the aluminum wire and the brass plate. At the brass-aluminum interface in sample A (fig. 10) a structure is observed with a nearly radial symmetry. X-ray microanalysis at the points indicated in figure 11 reveals that this region is an

FIGURE 10. Optical micrograph of reaction zone at an aluminum wire/brass plate interface.
Reaction zone circled. Sample A, table 1.

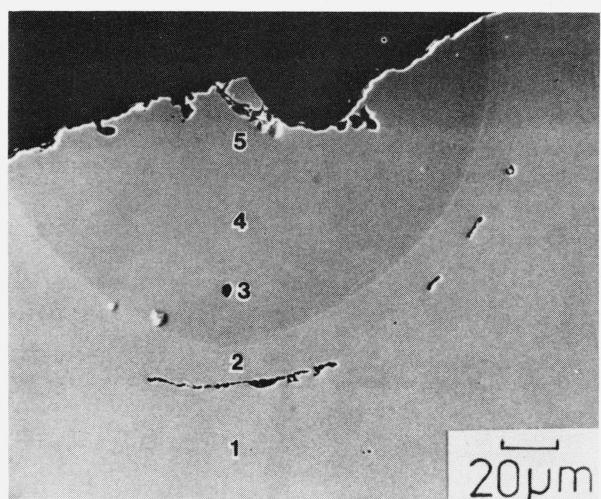
FIGURE 11. SEM micrograph of reaction zone in figure 10.
Analyses at numbered locations are listed in table 4.

aluminum-copper-zinc alloy which is slightly enriched in copper and strongly depleted in zinc as compared to the unaffected region of the brass plate (table 4).

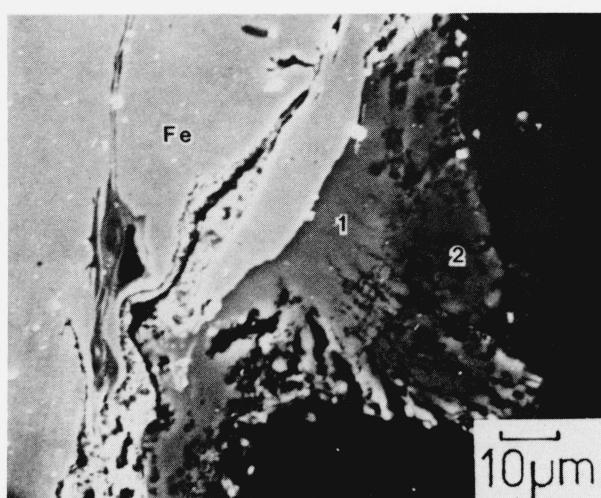
(a) *Aluminum wire/iron screw interface*. An example of a structure formed at the wire/screw interface during the early stages of a glow failure (sample C, table 1) is illustrated in figure 12. The structure consists of two distinct aluminum-iron regions with the compositions listed in table 5. The reaction region in figure 12 has only a small

FIGURE 12. *Incipient reaction zone at iron/aluminum interface.*
Analyses at numbered locations are listed in table 5.

percentage of the volume of the reaction zone developed in a sample such as A in which a sustained glow occurred. A major difference between the reaction zone formed in the initial stage and the fully-developed reaction zone is the detection of a large amount of zinc, which is derived from a galvanized zinc coating. In fully-developed reaction zones associated with galvanized screws, the zinc component is apparently lost by volatilization.

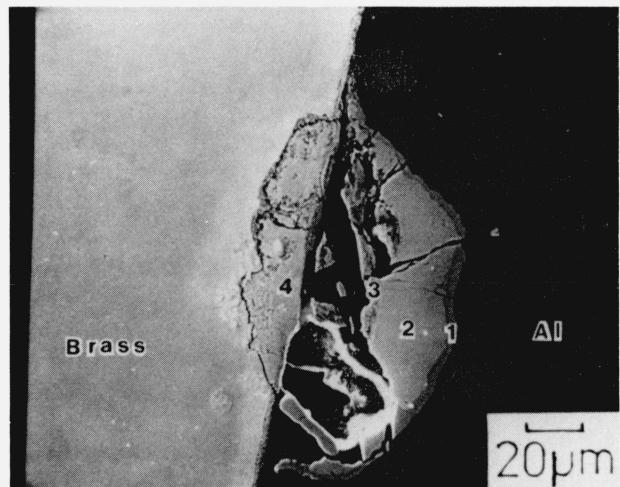
(b) *Aluminum wire/brass plate interface*. Two different types of structures are observed at the brass-aluminum interface. In one type of structure a complex layered reaction zone is found at the aluminum wire/brass plate interface during the initial stages of the failure (sample 1). A scanning electron micrograph (fig. 13) reveals that this region contains at least four distinct zones. The analyses of these areas (table 5) indicate that the formation of an aluminum-copper-zinc alloy has occurred during the failure.

FIGURE 13. *Incipient reaction zone at aluminum/brass interface.*

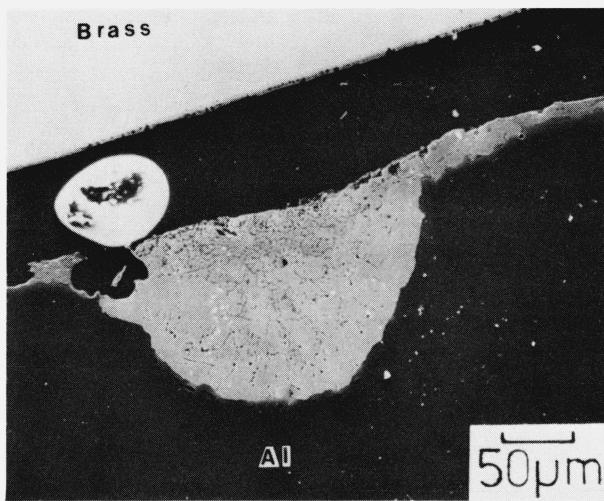
The aluminum content of the alloy increases near the wire. A second type of structure can be observed at the aluminum-brass interface (fig. 14(a)) which consists of a mixture of two distinct phases (table 5, sample C). The continuous phase "C" (fig. 14(b)) consists principally of aluminum and copper with a minor amount of zinc. In the discontinuous phase "D", aluminum and zinc are present as major constituents, while copper is a minor constituent.

FIGURE 14(a). *Incipient reaction zone at aluminum/brass interface.*

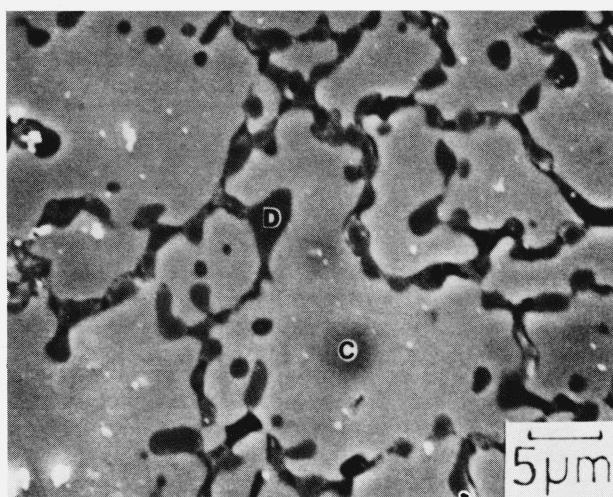
FIGURE 14(b). *Higher magnification image of figure 14(a) showing continuous ("C") phase and discontinuous phase ("D").*

phase structure observed in sample D [table 5(c)], the continuous phase is CuAl_2 (with a small amount of zinc) and the discontinuous phase is an aluminum solid solution.
